Alternative Buffer Materials Project

Comparison of the available buffer materials: advantages and disadvantages related to their hydraulic, mechanical and geochemical performance

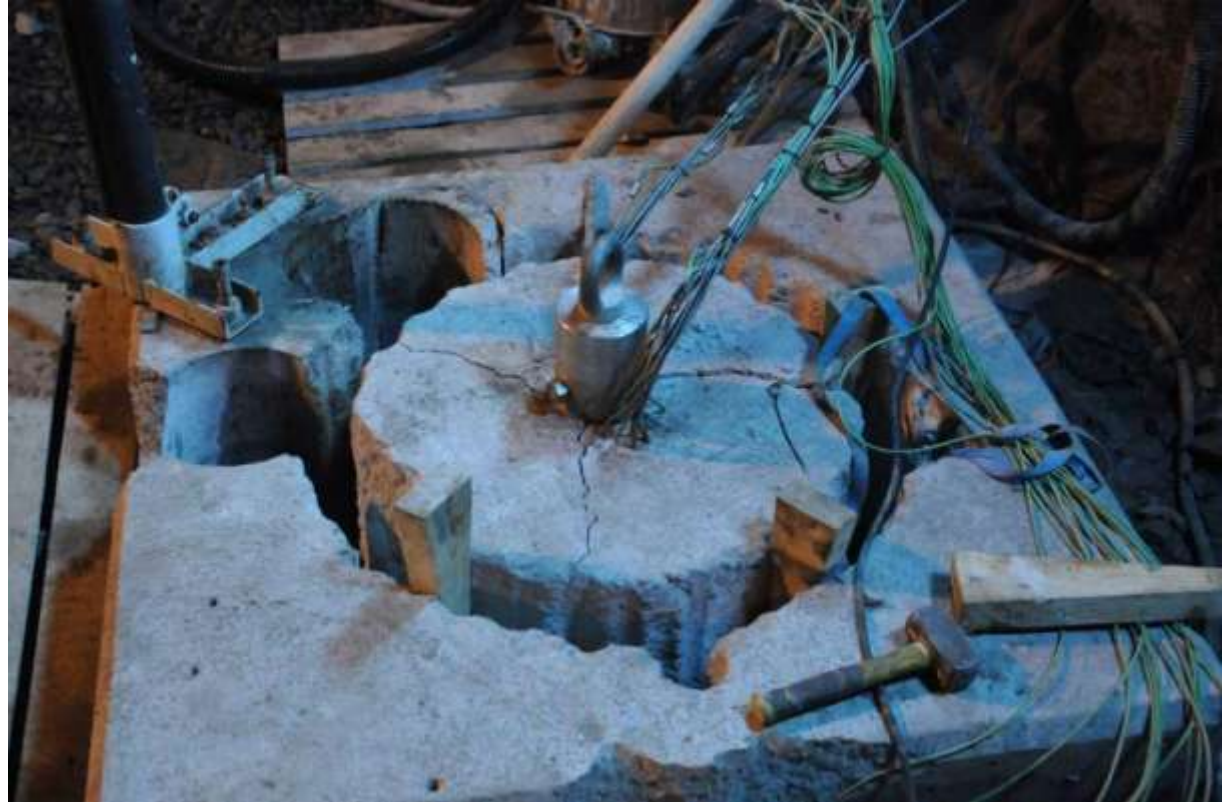
Termination of test package 1

- Seam drilling
- 2 x core drilled holes (d=300 mm)

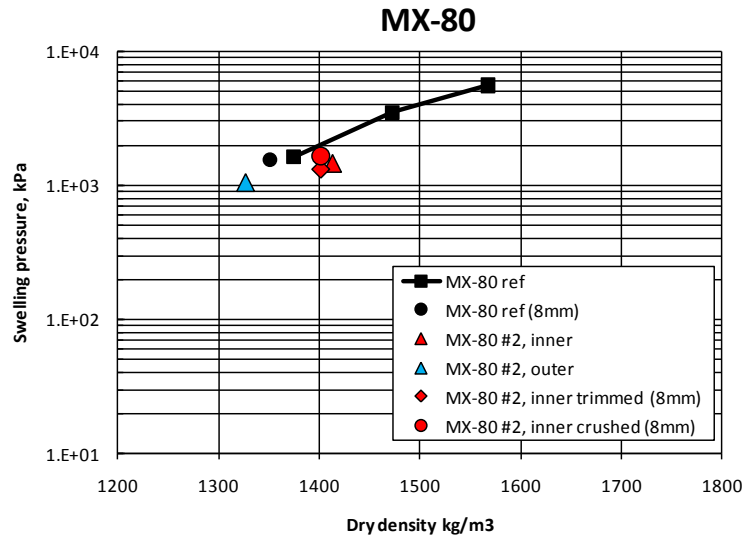
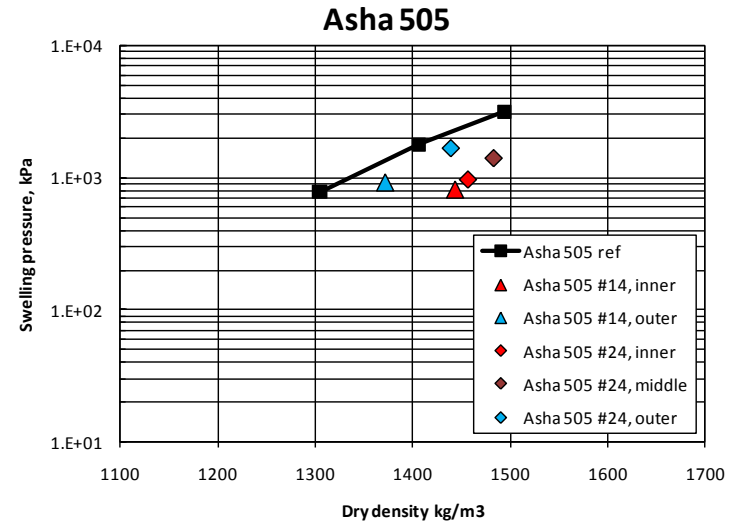
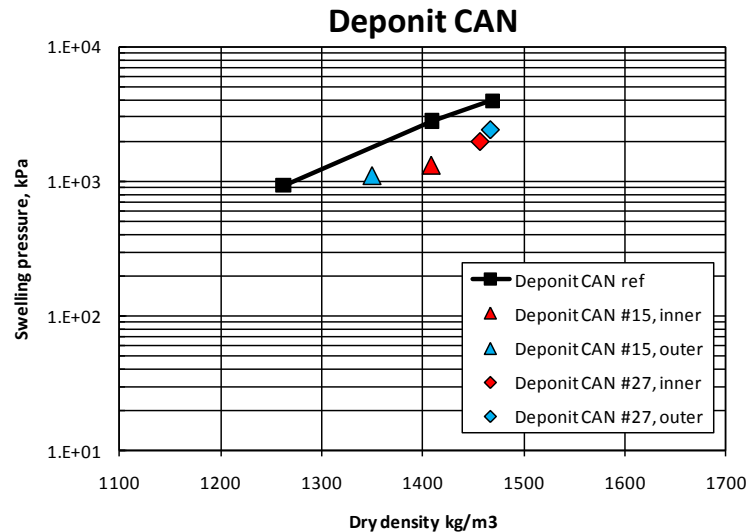
Swelling pressure

- There is a tendency that the swelling pressure of the test material is lower than the reference material
- The amount of tests is limited

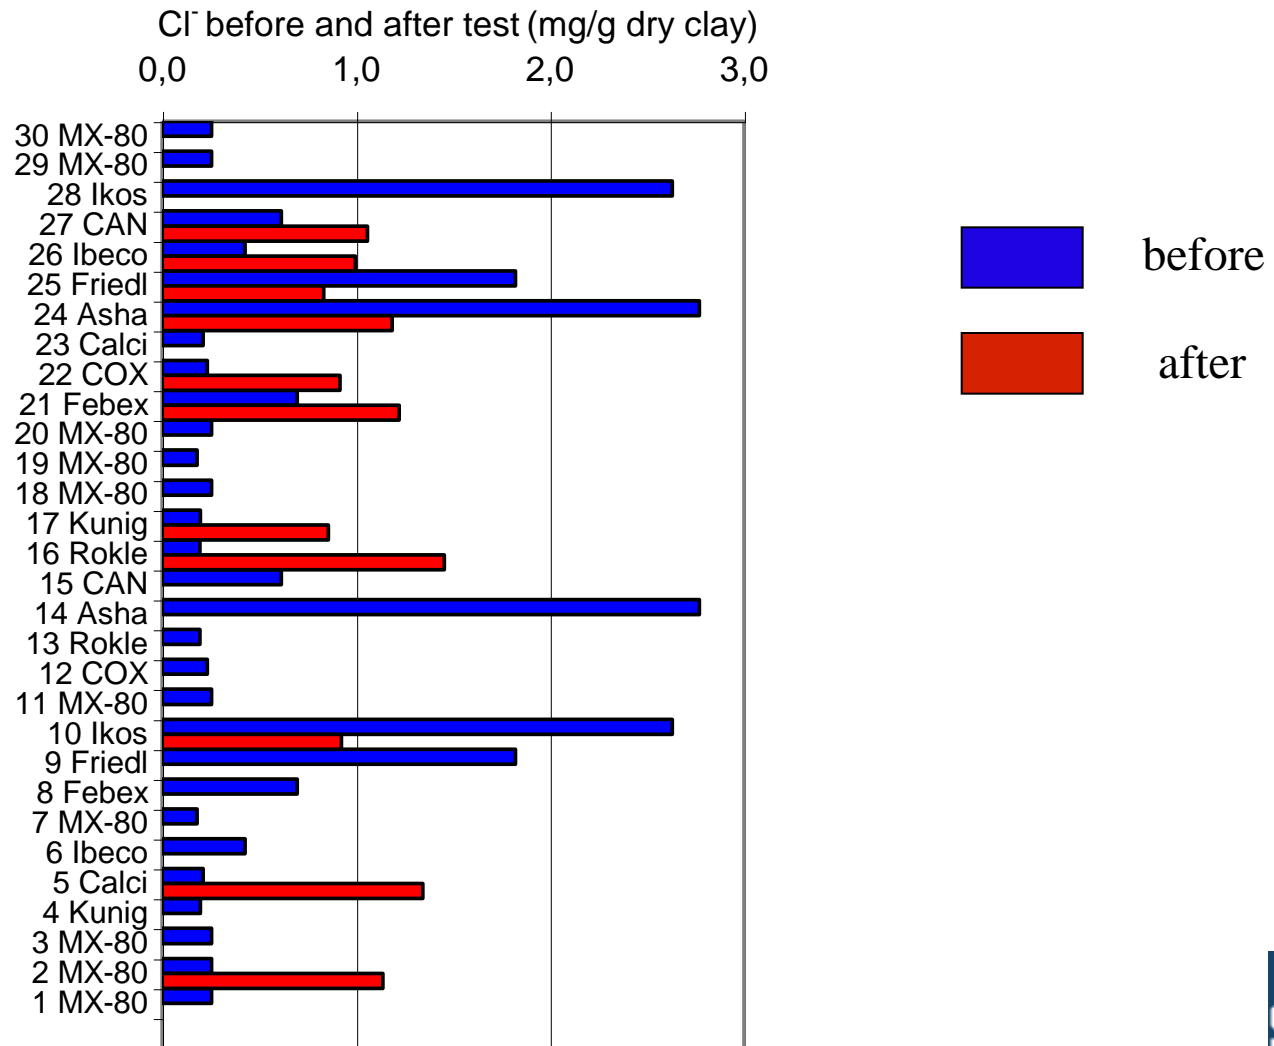
Chloride before and after the test

- The saturation with groundwater resulted in more or less constant chloride concentration in all blocks
- differential equilibration of the exchangeable cation pool in the upper and lower part of the package
- Iron has been incorporated in the bentonite closest to the steel tube
- All blocks are depleted in magnesium and the loss is at a maximum in the outer parts
- Carbonate dissolution increases with temperature
- Nature of the trioctahedral mineral / domains?

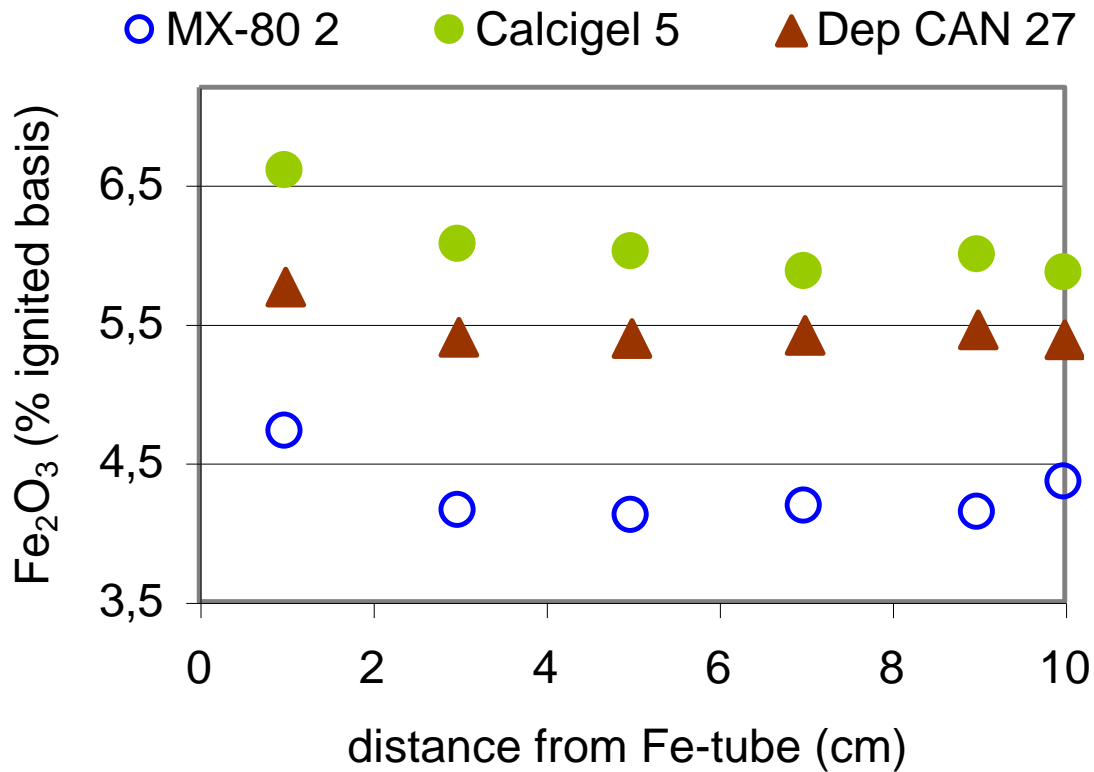
Iron distribution, bulk samples (Clay Technology)

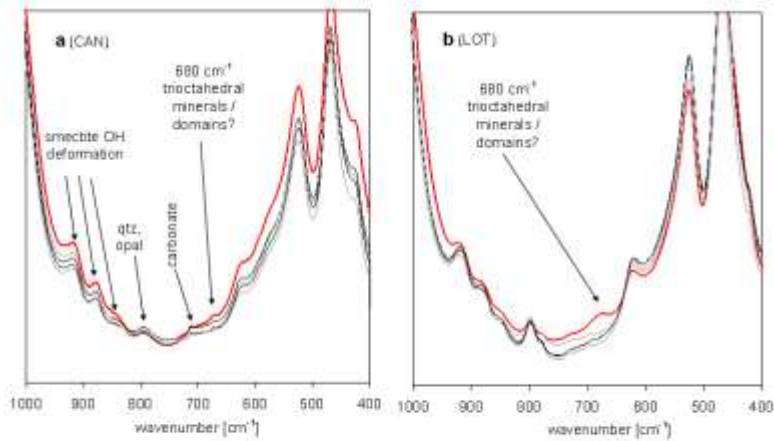
Trioctahedral minerals/domains

250 Abb 13: IR spectra of samples CAN and LOT showing increased 680 cm⁻¹ intensity

251 which can not be attributed to precipitation of sulphates.
